## Building Accessibility Audit Validation Report

895 Eastern Ave. (53,000 sf)

Toronto Fire & EMS Training Centre

Submitted to the City of Toronto  
by IBI Group  
Version 1: May 21, 2021

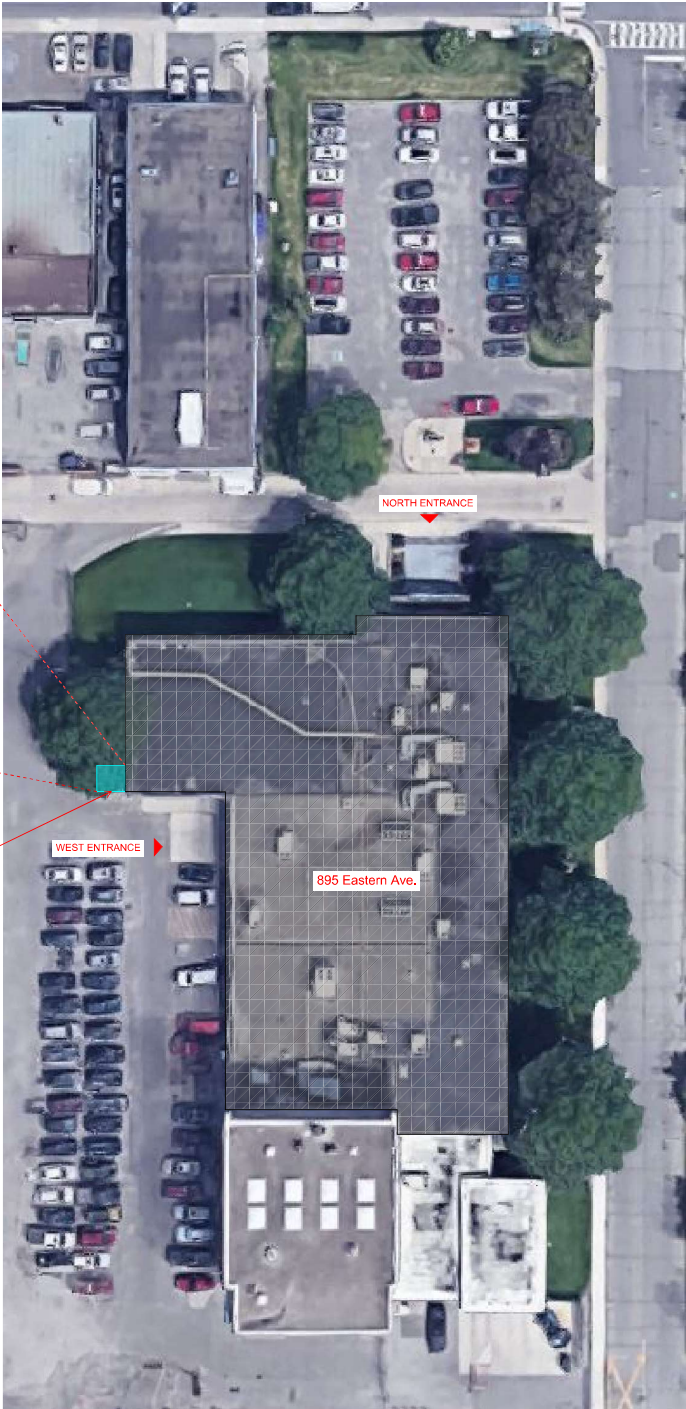
ID 23: Replace existing picnic table and provide 1 TADG compliant picnic table with the required extension with the underside knee and toe clearance.

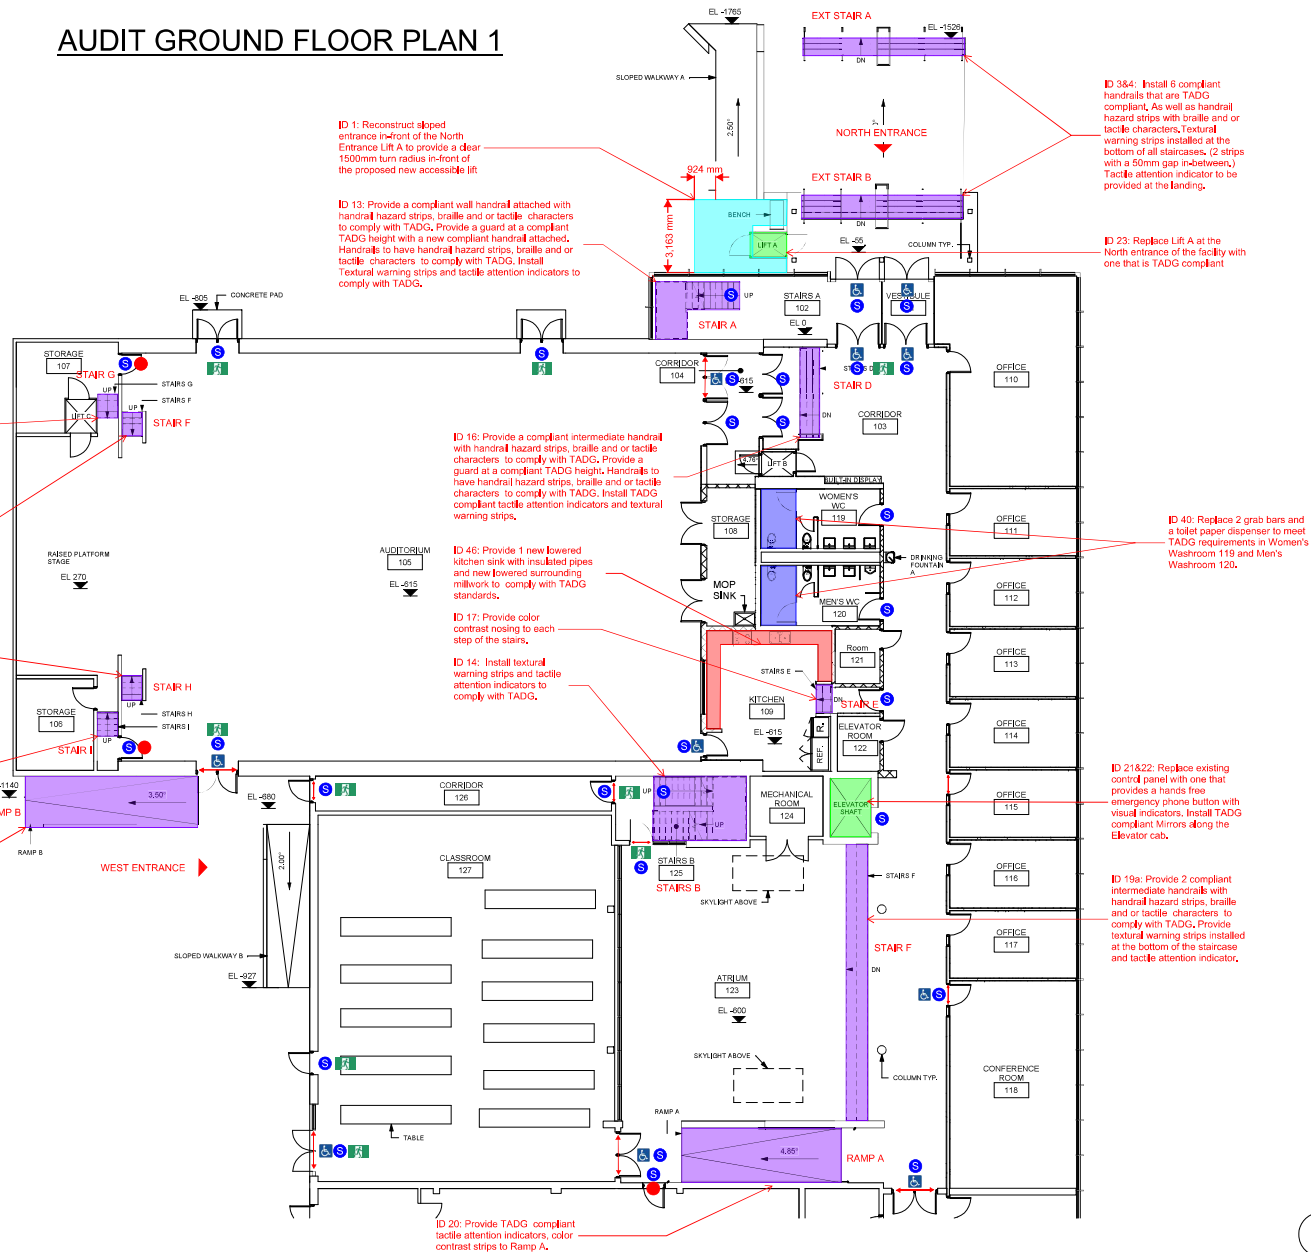
# AUDIT GROUND FLOOR PLAN 1

**ID 1: Reconstruct sloped entrance in-front of the North Entrance Lift A to provide a clear 1500mm turn radius in-front of the proposed new accessible lift**

**ID 23: Replace Lift A at the North entrance of the facility with one that is TADG compliant**
